## COMPANY STATEMENT

(Reference JVM410 midi connections on product)

Ground loop hum detected when connecting the JVM410 to multiple effects set-ups with MIDI.

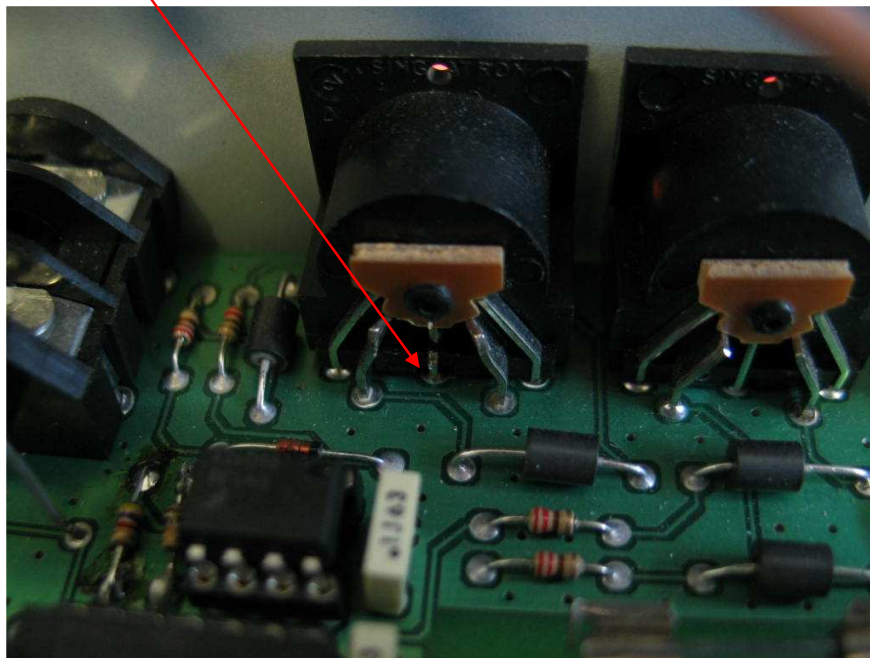
Cut DGND pin at SK2 pin 2 as shown

Remove DGND connection from pin #2 of SK2 DIN socket (MIDI IN). This leaves that pin unconnected which is fine.
